### WELDING INSPECTION REPORT

Resident Engineer: Casey, William **Report No:** WIR-027884 Address: 333 Burma Road **Date Inspected:** 01-Jul-2012

**OSM Arrival Time:** 700 **Project Name:** SAS Superstructure **OSM Departure Time:** 1530 **Prime Contractor:** American Bridge/Fluor Enterprises, a JV Contractor: American Bridge/Fluor Enterprises, a JV **Location:** jobsite

34-0006 **Bridge No: Component:** OBG

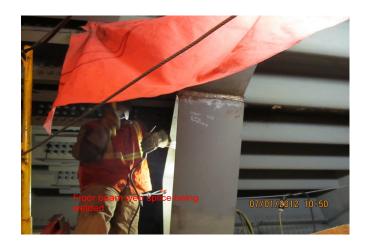
QAI observed the preheating of weld joint W12 Corner Drop-In W2.1 by Welder Roby Smith, utilizing the use of a rosebud torch. The joint was preheated to a Quality Control Recorded; Quality Assurance verified temperature of 150F. This QAI observed QC inspector Fred Michaels take multiple temperature readings along the length of the weld joint prior to the start of welding operations, and after work stoppages randomly throughout the day. Inspector Michaels was using an Infrared non-contact heat gun to record preheat temperature, this QAI verified readings using a Tempil Stick at random intervals throughout the day.

This QAI observed Roby Smith utilizing the Flux Cored Arc Welding Process to the following parameters 242 amps, 28 volts, which fall within the range of the governing Welding Procedure Specification ABF-WPS-D15-F3200-2. This QAI observed Quality Control Inspector Fred Michaels recording welding parameters at various times throughout the shift and this QAI verified parameters at random intervals.
